Prevention of Leakage in Tokyo

2024

Bureau of Waterworks, Tokyo Metropolitan Government

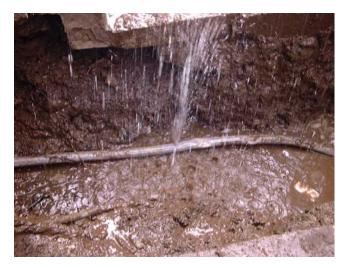
Fig.11 Leakage from lead pipes

Most of leakages occur in old and corroded service pipes (Reference-3), and they are accounted for about 96% of the total leakage repair cases. Consequently, in order to reduce leakages, it is extremely effective to prevent from them in advance. In Tokyo, we used to use "lead" for service pipes which is easy to construct. However, lead has been a major cause of leakages due to its low intensity and easy to corrosion.

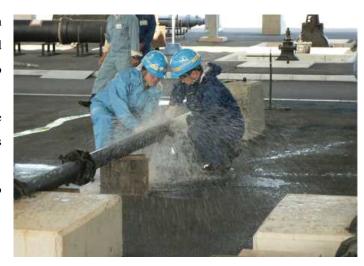
Fig.18 Technical training for leakage prevention work

There are pipeline facilities for experiments and verification to resolve problems about pipeline. These facilities are similar to actual condition and utilized not only for staff of Tokyo waterworks but neighboring and overseas waterworks companies.

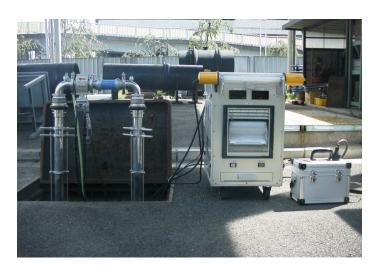
Fig.20 Minimum flow meter

This equipment is jointly developed by Tokyo Waterworks and a private company

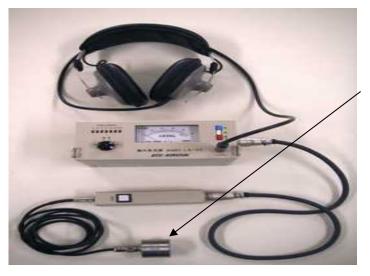
Fig.22 Electronic leakage detector

Detector (Pickup)

In the patrol works are individual investigation work that determines leakage with "leakage sound detection bar" (Fig.21) by putting to water meter on every house, acoustic investigation work that is conducted during the night when there is less traffic to identify point of leakage with electronic leakage detector (Fig.22) from the road surface.

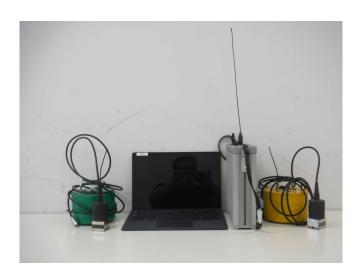
Fig.25 Correlative leakage detector

The correlative leakage detector equipment was jointly developed by Tokyo Waterworks and private company.
