Prevention of Leakage in Tokyo

2025

Bureau of Waterworks, Tokyo Metropolitan Government

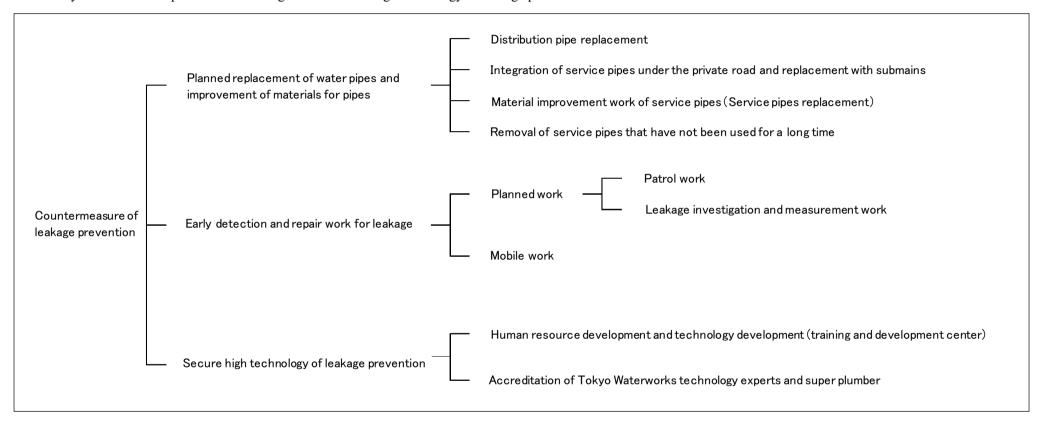
Fig.6 System of leakage prevention measures

Tokyo Waterworks is working on leakage prevention measures based on the pillars of "Planed replacement of water pipes and improvement of materials for pipes", "Early detection and repair work for leakage" and "Secure high technology of leakage prevention".

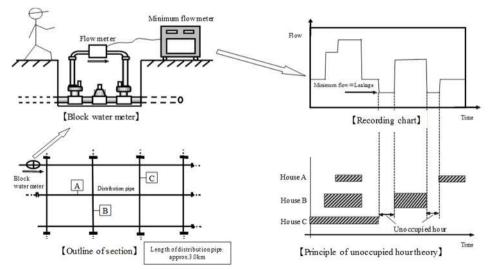
Fig.19 Theory of minimum night flow measurement method

First, close gate valves surrounding the block to be investigated shut the water flow from other blocks. Then the water is sent only through minimum flow measuring equipment set in the block water meter and measure the flow rate. The measured minimum flow rate (The quantity of flow indicated in spite of a situation where nobody is expected to use water) is considered to be the leakage.

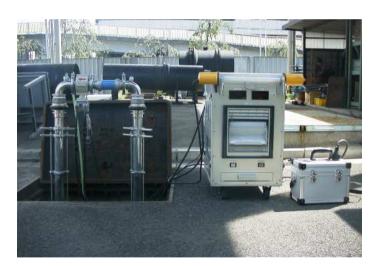
Fig.20 Minimum flow meter

This equipment is jointly developed by Tokyo Waterworks and a private company

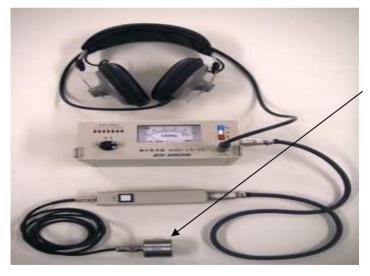
Fig.22 Electronic leakage detector

Detector (Pickup)

In the patrol works are individual investigation work that determines leakage with "leakage sound detection bar" (Fig.21) by putting to water meter on every house, acoustic investigation work that is conducted during the night when there is less traffic to identify point of leakage with electronic leakage detector (Fig.22) from the road surface.

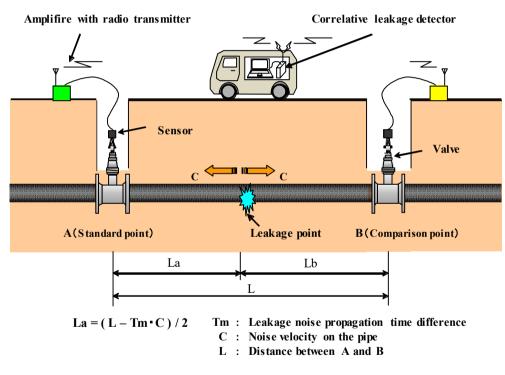
Fig.24 Theory of the correlative leakage detection method

Firstly we place sensors at two points (i.e. gate valve and fire hydrant) span water leakage might be occurred, then obtain the leakage noise propagation time difference from both sensors with correlative leakage detector. The position of leakage is calculated by the time lag, distance between sensors, and velocity of leaking sound transmitting through the pipe.

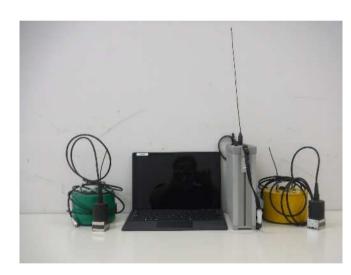
Fig.25 Correlative leakage detector

The correlative leakage detector equipment was jointly developed by Tokyo Waterworks and private company.

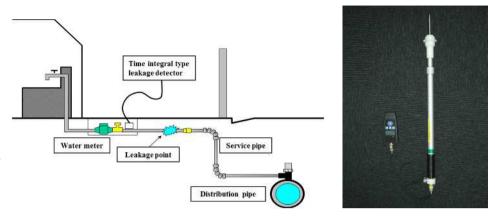
Fig.26 Time integral type leakage detector

It has excellent characteristics such as being largely unaffected by intermittent sound of water use or traffic noise transmitted through the ground, and not requiring skill to operate.

The time integral type leakage detector was jointly developed by Tokyo Waterworks and private company.

In addition to that, we consign administrative organizations (Tokyo Water Co., Ltd.) to conduct such individual investigation with time integral type leakage detector (Fig.26) replacing leakage sound detection bar on some blocks since FY2003.

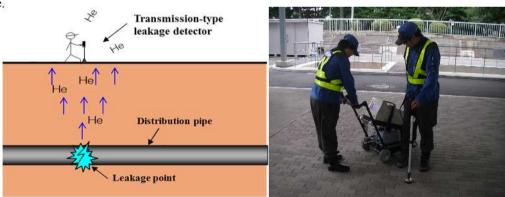
Fig.27 Transmission-type leakage detector

This type of method can detect very small amount of leakage or leakage in main pipes such as main distribution pipes buried deep underground since it is not based on the leakage sound as it is necessary with the acoustic leakage sound detection method or the correlative leakage detection method.

The equipment used for the transmission-type leakage detector was jointly developed by Tokyo Waterworks and private company.

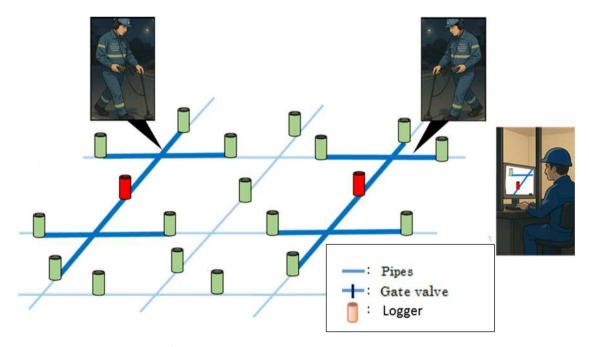
Fig.28 Multipoint correlation type leakage detector

The multipoint correlation type leakage detector is a device that detects leaks by installing loggers at multiple locations in the accessory equipment of water distribution pipes (water control valves, fire hydrants, etc.) and having the loggers detect and analyze the sound of leaks transmitted through the water pipe bodies.

This device can determine the presence of water leakage even in pipelines that are buried in deep locations or under tracks, where it is difficult to use the sound audition method, and can survey a wide area at a time. It also has features such as being less susceptible to ambient noise and not requiring specific skills for the work.

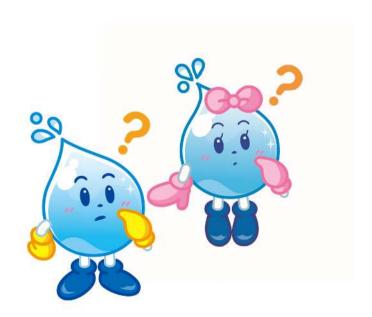
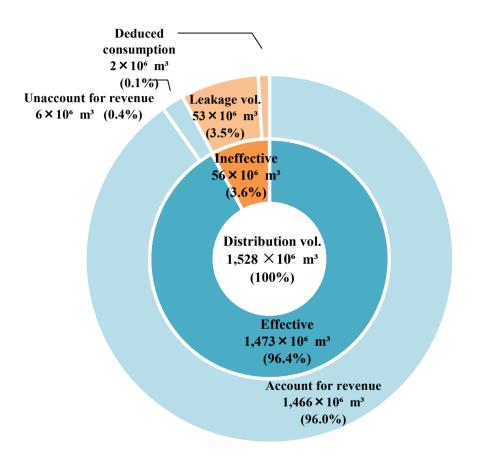
Reference-1 Distribution volume analysis in FY 2024

Water Volume (m³/year)	Component Rate (%)
Г	istribution total	1,528,132,500	100.0
	Effective	1,472,529,195	96.4
	Account for revenue	1,466,118,287	96.0
	Unaccount for revenue	6,410,908	0.4
	Ineffective	55,603,305	3.6
	Leakage	53,461,099	3.5
	Deduced consumption by settlement	2,142,206	0.1

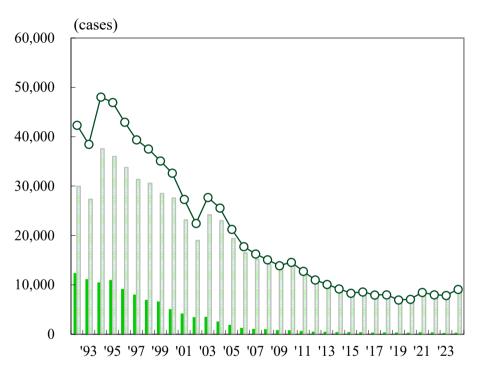
Reference-4 Trends in number of each kind of repair works from FY 1992 to FY 2024

'92	'93	'94	'95	'96	'97	'98	'99	'00	'01
Planned work	cases	12,383	11,142	10,505	10,979	9,177	8,028	6,964	6,627	5,073	4,199
Mobile work	cases	29,960	27,337	37,542	35,965	33,757	31,345	30,575	28,476	27,569	23,135
Total	cases	42,343	38,479	48,047	46,944	42,934	39,373	37,539	35,103	32,642	27,334
		'02	'03	'04	'05	'06	'07	'08	'09	'10	'11
Planned work	cases	3,450	3,516	2,592	1,908	1,287	1,097	1,026	848	801	684
Mobile work	cases	18,996	24,186	22,987	19,361	16,460	15,173	14,083	13,046	13,777	12,090
Total	cases	22,446	27,702	25,579	21,269	17,747	16,270	15,109	13,894	14,578	12,774
		'12	'13	'14	'15	16	'17	'18	'19	'20	'21
Planned work	cases	542	503	454	434	403	357	383	361	306	402
Mobile work	cases	10,476	9,597	8,752	7,881	8,168	7,620	7,623	6,618	6,790	8,097
Total	cases	11,018	10,100	9,206	8,315	8,571	7,977	8,006	6,979	7,096	8,499
		22	23	24							
Planned work	cases	386	273	315							
Mobile work	cases	7,628	7,612	8,802

Total	cases	8,014	7,885	9,117

Leakage is classified into two types by its form; "surface leakage" that flows out to surface of the ground and "underground leakage" that leaks out underground without any appearing on the surface. Basically, leakages occurring above the ground are dealt with mobile work - repair within the day - and p those occurring underground are dealt with planned work. The Figure 4 shows the ratio of mobile work and planned work. There were 8,802 repairs by mobile work and 315 by planned one in the FY 2024(Reference -4).

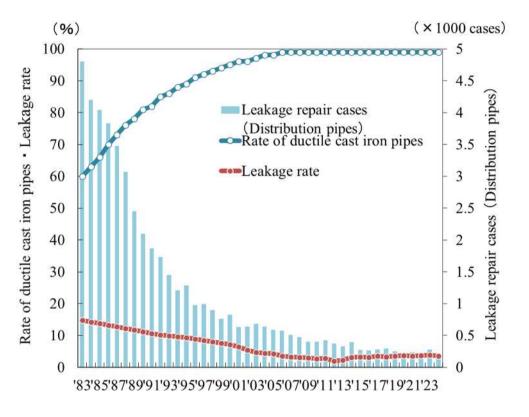
Reference-5 Trends in rate of ductile cast iron pipes in distribution pipes, leakage repair cases(distribution pipes), leakage rate from FY 1983 to FY 2024

X Rate of ductile cast iron pipes:

(Until 2019) The proportion of ductile cast iron pipes to the extension of iron pipes in distribution pipes $\,$
